# PRELIMINARY DRAINAGE REPORT

## **Eaglemont 4**

13511 191st Avenue S.E.  
Monroe, Washington

June 22, 2016  
Revised August 25, 2016

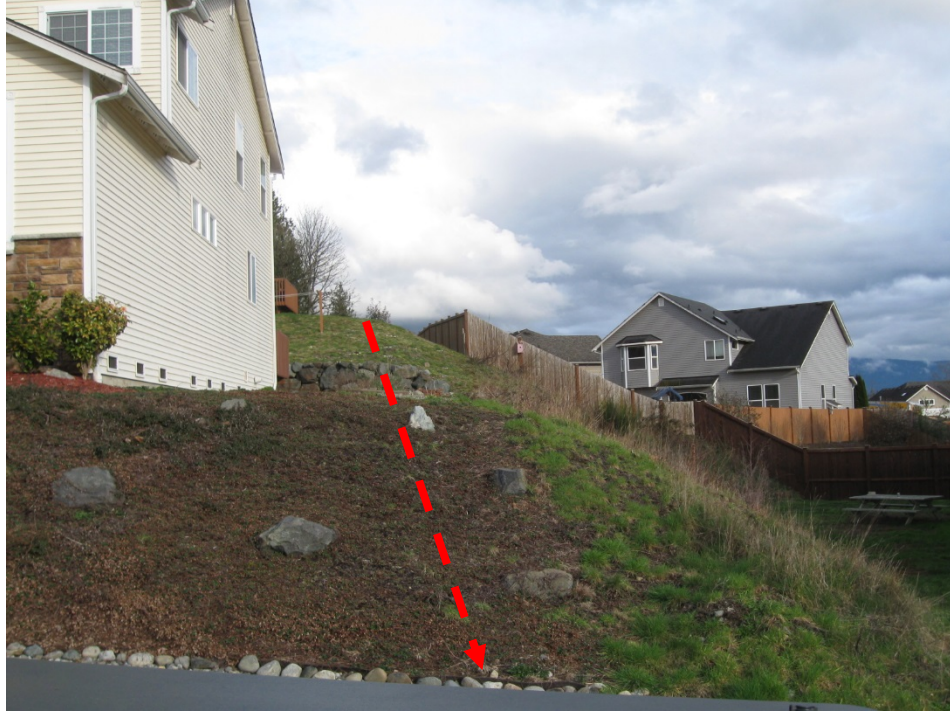
Looking east. Existing 18" ductile iron pipe stemming westward from Eaglemont Phase 5-8 into the Sinclair Heights plat towards stubbing in the vicinity of 193<sup>rd</sup> Dr. SE.

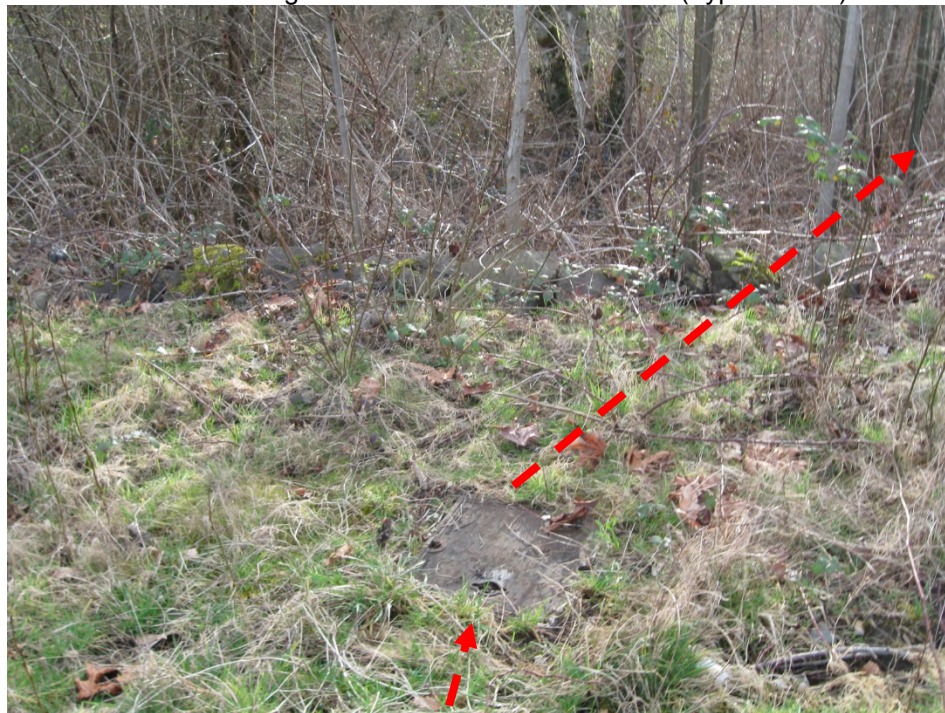
Existing ASB CB 1B (Type 2 – 48"). with 18" inlet SD draining southwest. Flows exit via a 24" SD draining southwest through a heavily forested WSDOT easement towards 191<sup>st</sup> Ave SE.

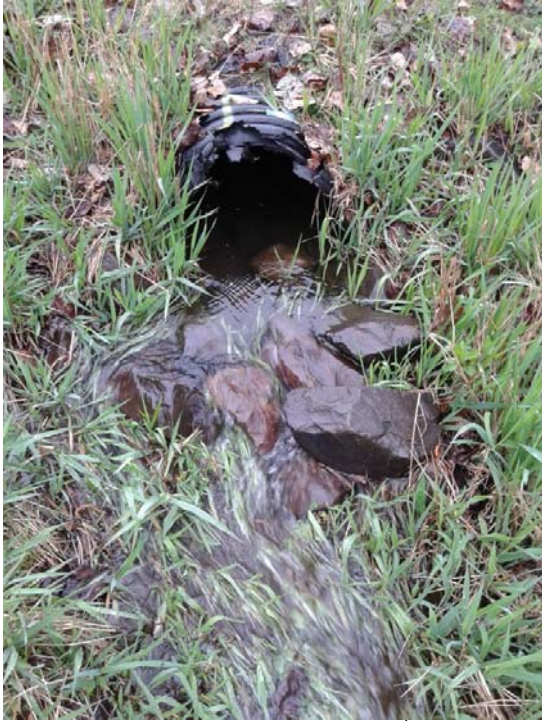
Flows exit on the east side of 191<sup>st</sup> Ave SE via an 18" plastic storm pipe, into an existing roadside ditch.

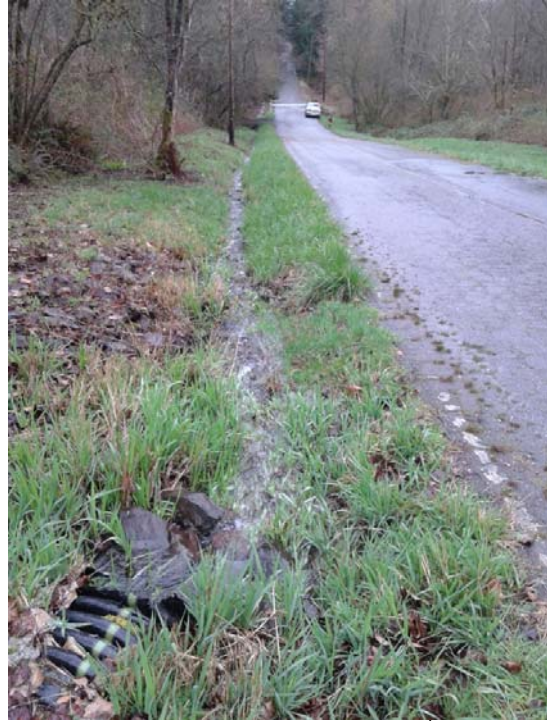
Flows drain south adjacent to 191<sup>st</sup> Ave SE.

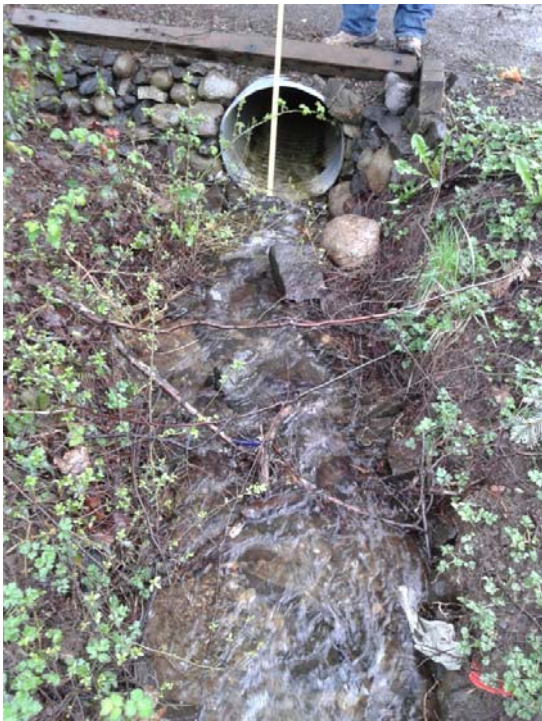
Flows pass under an existing driveway within an existing 24" corrugated metal storm pipe. Flows continue draining south.

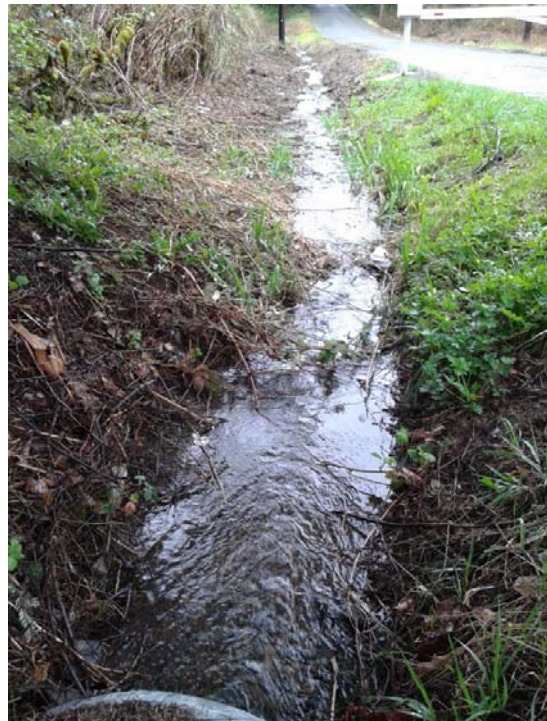
Flows drain south adjacent to 191<sup>st</sup> Ave SE.

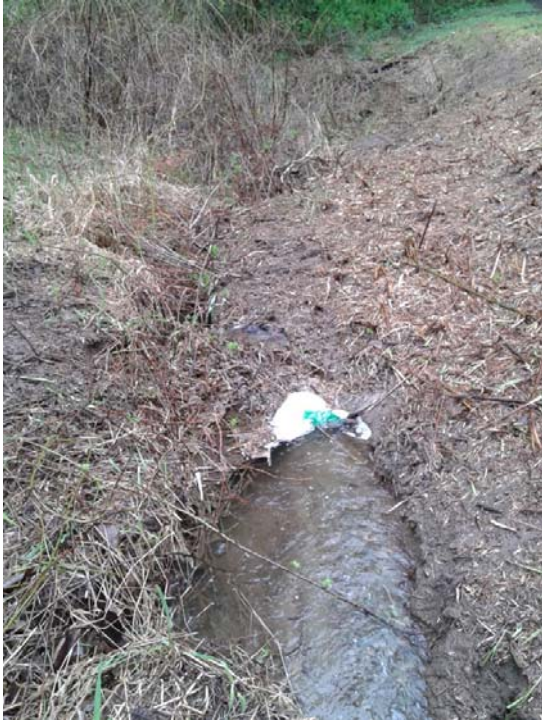
The roadside ditch flows south and drops into a deep gully on the east side of 191<sup>st</sup> Ave SE.

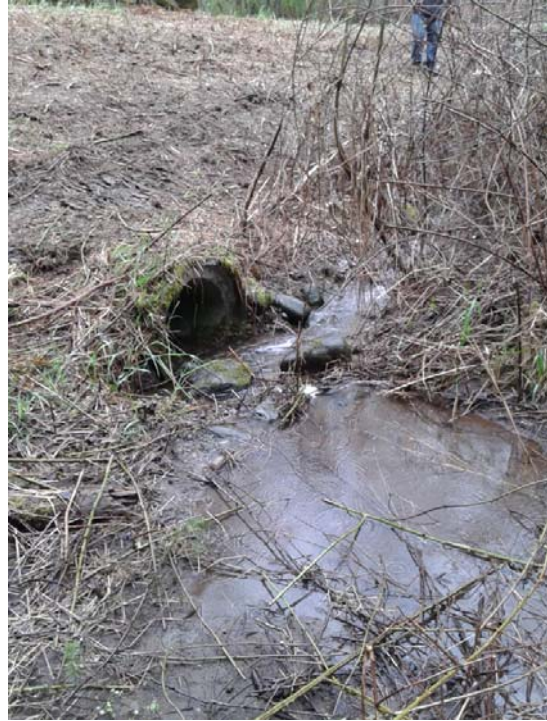
Site flows join another stream before entering a 24" concrete pipe that crosses west under 191<sup>st</sup> Ave SE.

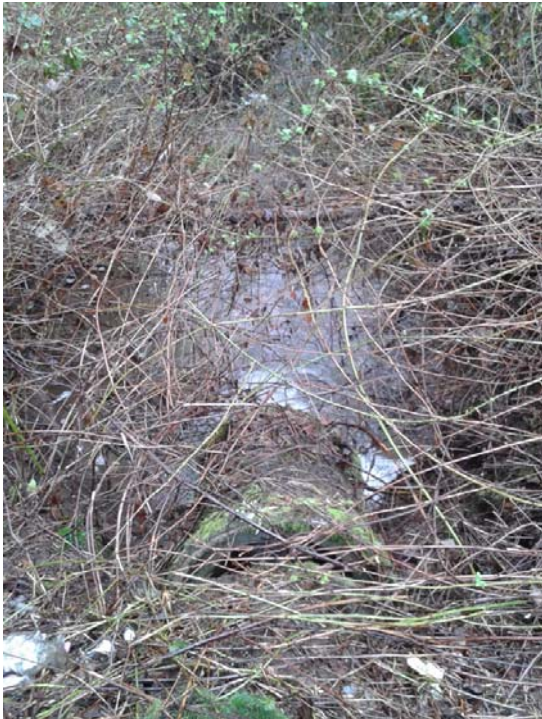
Flows exit the west side of 191<sup>st</sup> Ave SE via a 24" concrete pipe.

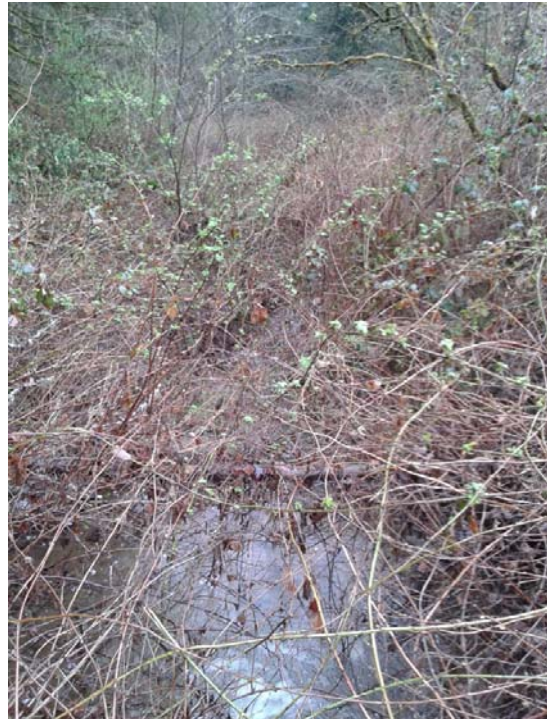
Flows continue draining west and begin the headwaters of Arena Creek (E. Segment) before flowing into the Arena Creek Wetland drain.
